REPORT OF COMPLIANCE MONITORING INSPECTION
at
Acadia Subdivision Plat 2
Northwest of the intersection of Meredith Drive and 160th Street, Urbandale, Iowa, 50322
NPDES Permit Number: (23817-23576)
October 13, 2016

U.S. ENVIRONMENTAL PROTECTION AGENCY
Region 7

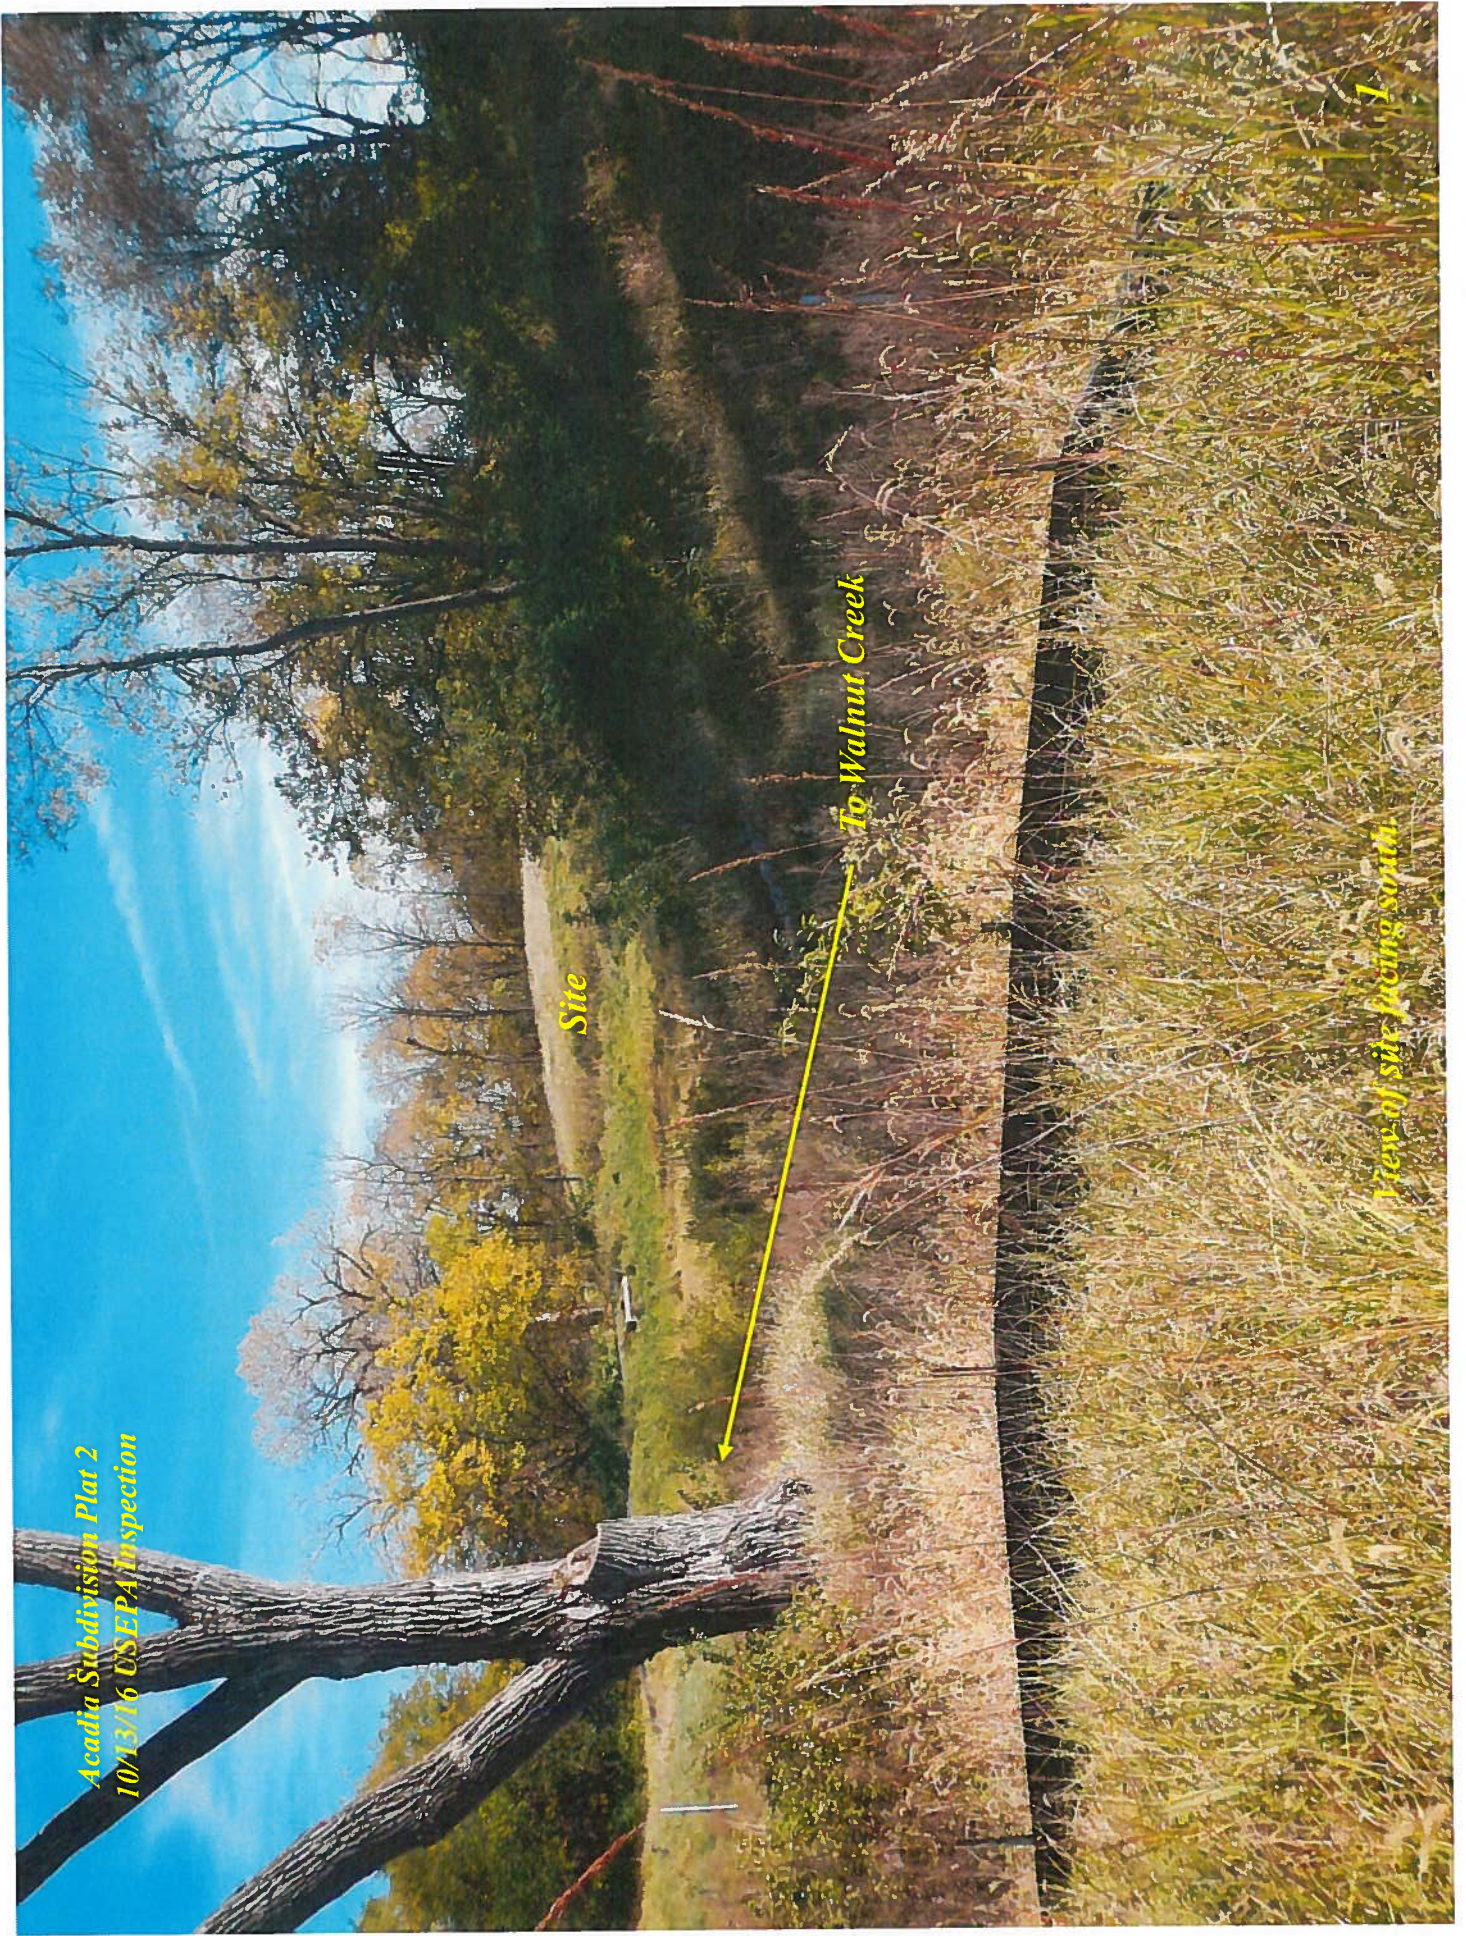
1

View of site facing south

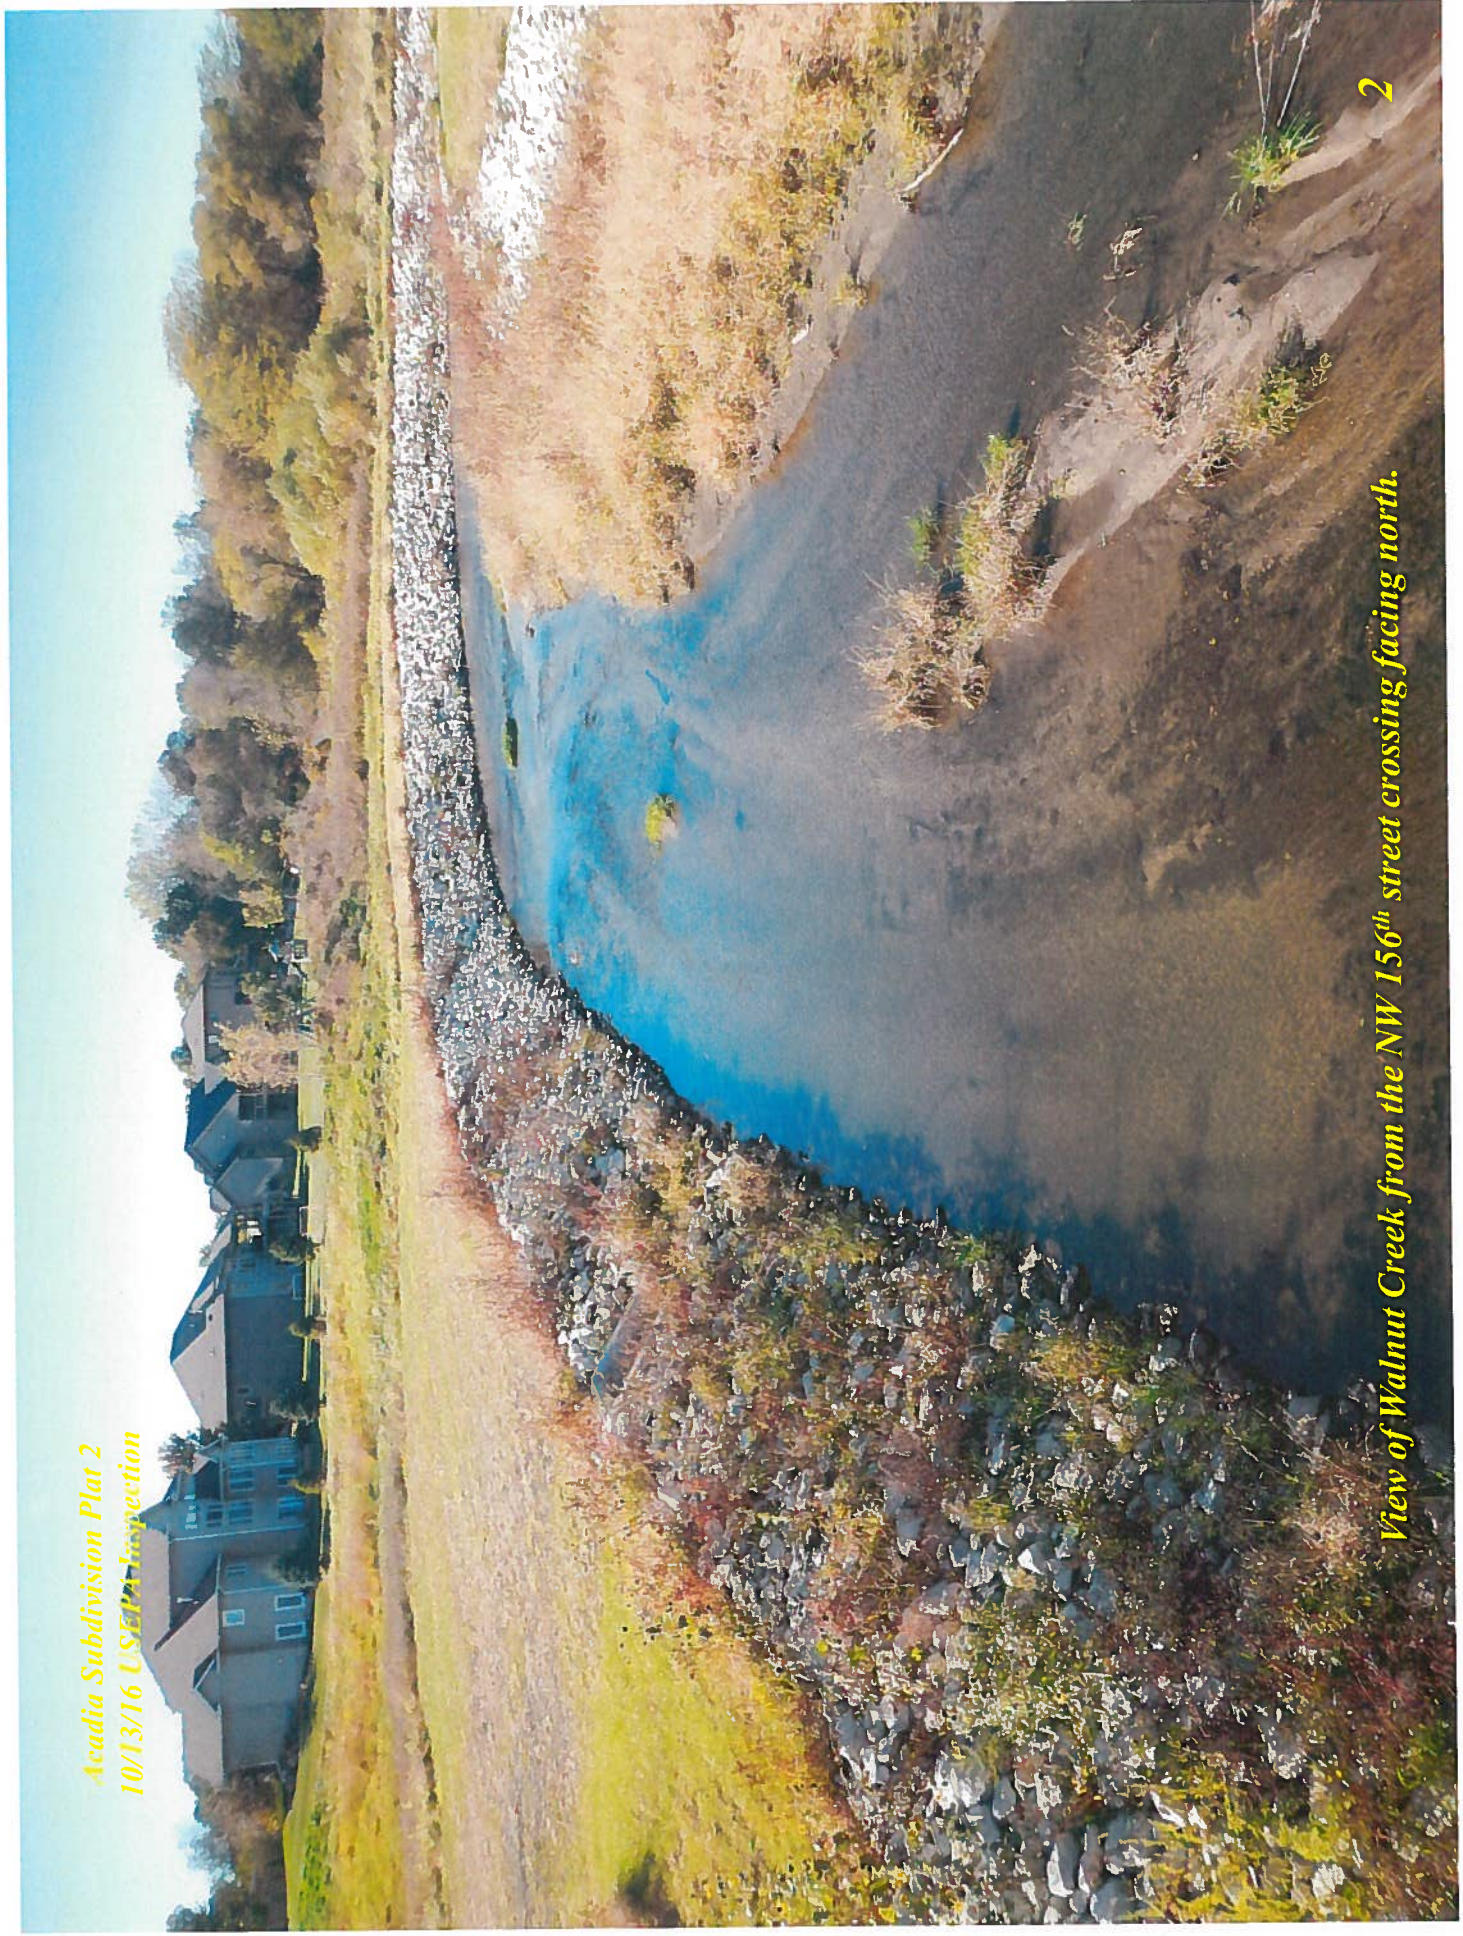
View of Walnut Creek from the NW 156th street crossing facing north.

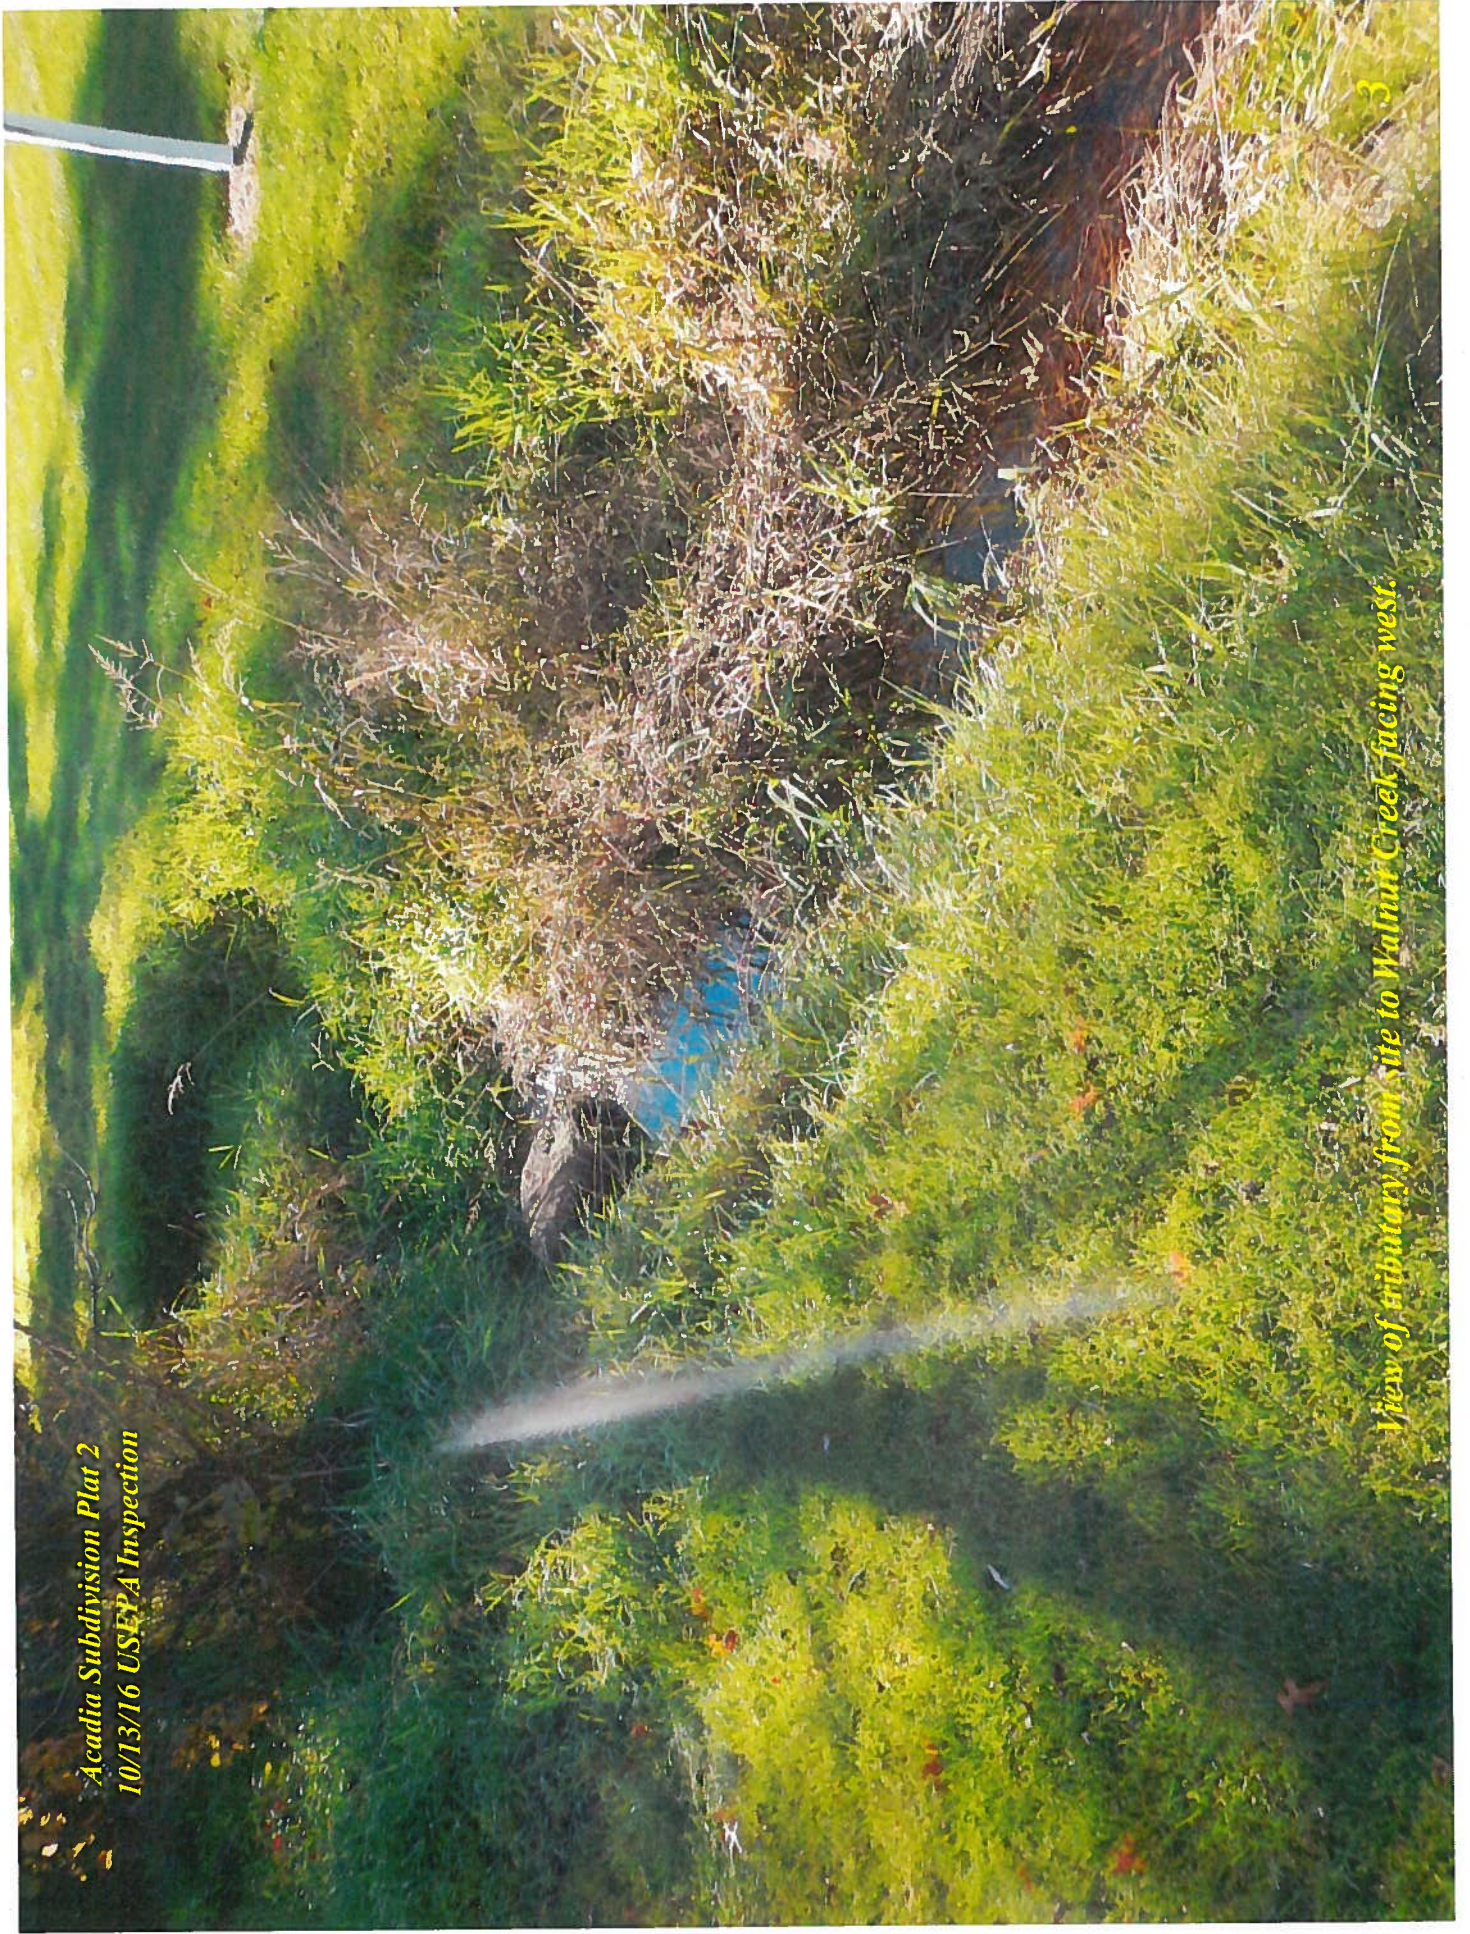
3

View of tributary from site to Walnut Creek facing west.

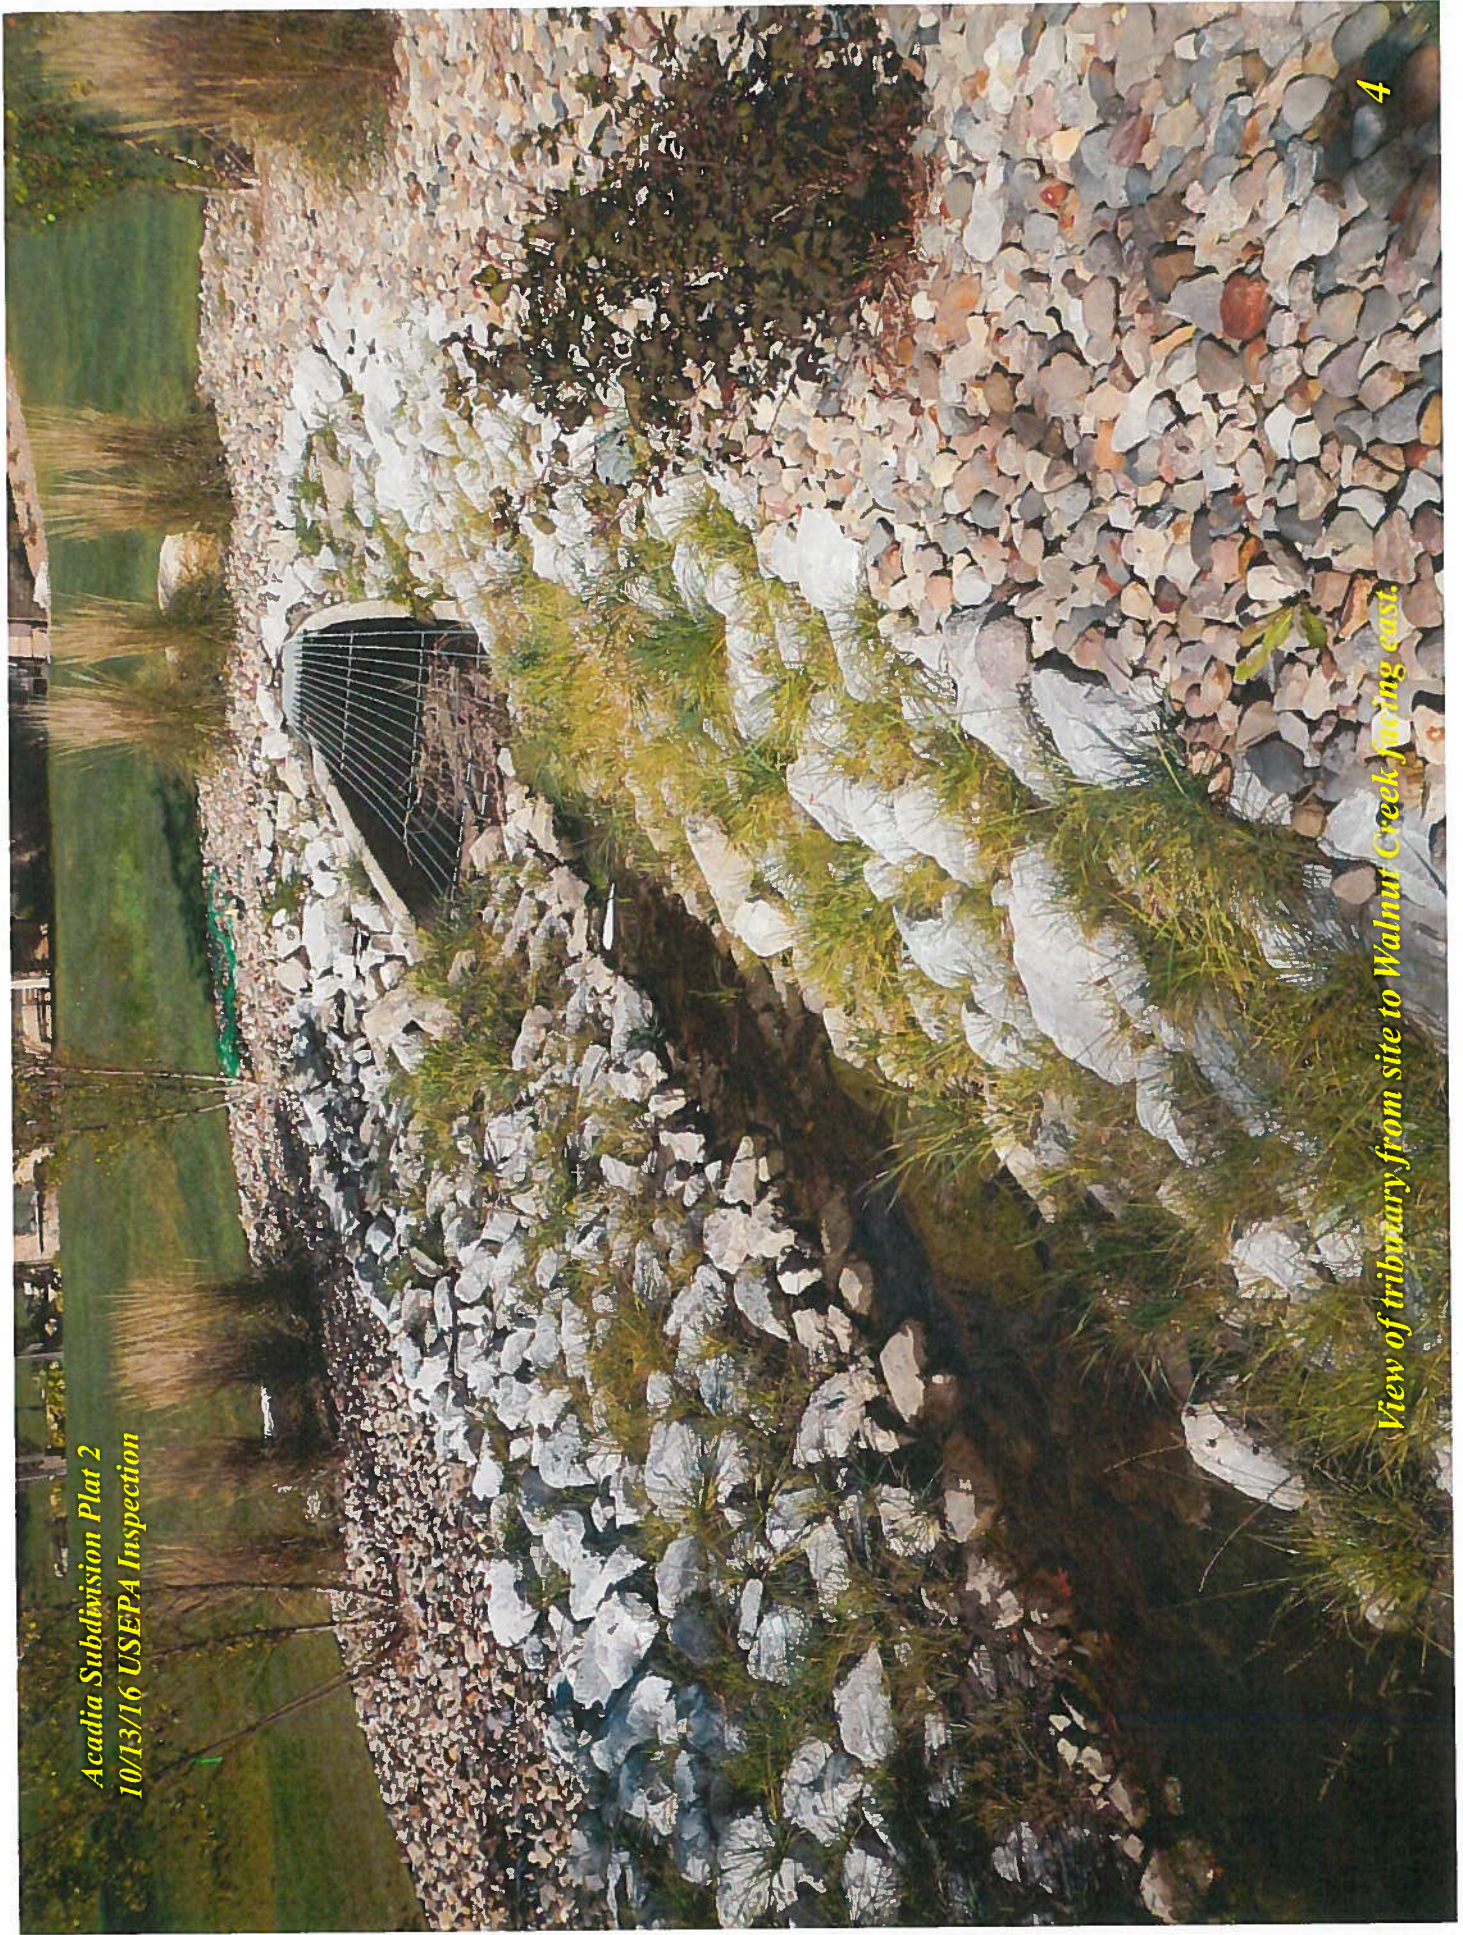
View of tributary from site to Walnut Creek facing east.
